Case Study 5: General External Corrosion

Job Details

- 6" Gas line
- Painted pipe surface
- Pipe resting on simple supports
- Desert Terrain

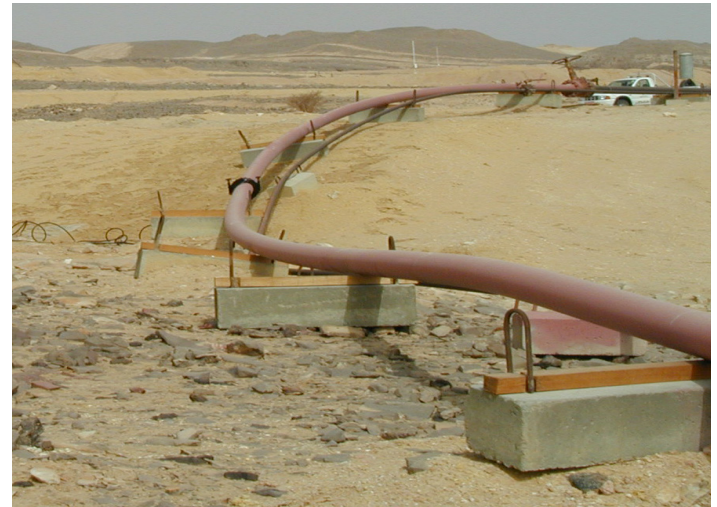
An overview of the pipeline resting on simple supports

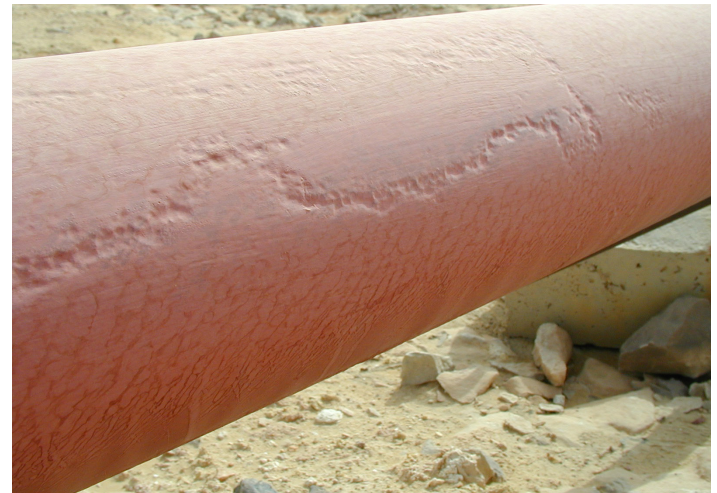
- Over 70m of pipeline was inspected
- The extend of general corrosion was evaluated
- Isolated medium corrosion patches were identified

A close-up of the general corrosion on the pipeline.
