Guided Wave Monitoring of Caissons

Case Study 20

Caissons

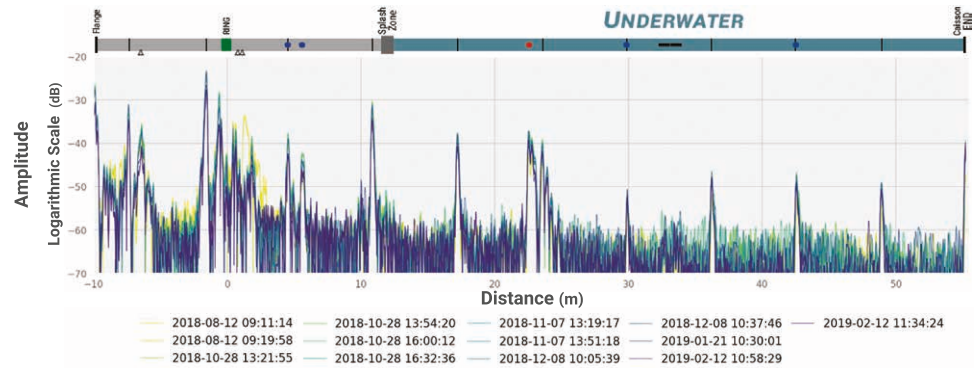
WavePro™ Results

gPIMS® GWT Results. Comparison of data taken over 6 months indicates condition changes have been minimal.

The GWT and Thickness Measurements plots for one of the caissons are shown above. It can be seen that thickness has not changed substantially in this period. Minor changes have been detected in the GWT data at the location of one of the caisson's guides, caused by some remedial work done to prevent the caisson from moving in the guide.

The data obtained with the gPIMS® compares very well with the initial screening result (see results of Caissons screening in Case Study 18). However, the increased signal amplitude from the gPIMS® has resulted in a significant increase in test range, which allows monitoring of the condition of the full length of the riser: from the top flange - 20m above sea level - to the bottom of the caisson - 45m below sea level.

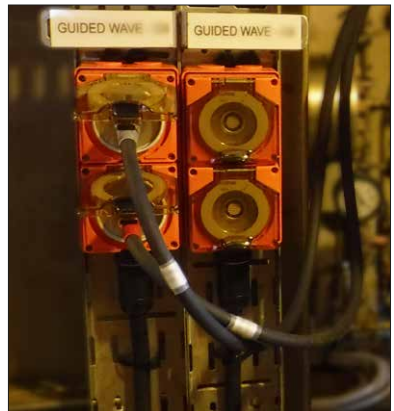
gPIMS® Connection Boxes. Installed in an easily accessible location for frequent data acquisition.

Two caissons were selected for installation of the gPIMS® system, placing the sensors at the same location used for the initial screening: approximately 10m above the splash zone. Cables from the sensors were run through conduits to the lower deck of the platform, where the sensor connection boxes are easily accessible. Currently data is being collected by a minimally trained operator using a portable instrument.
