Case Study 10: Locating Defects in Elbows

- 16" Crude Oil line
- Tight 1D elbows

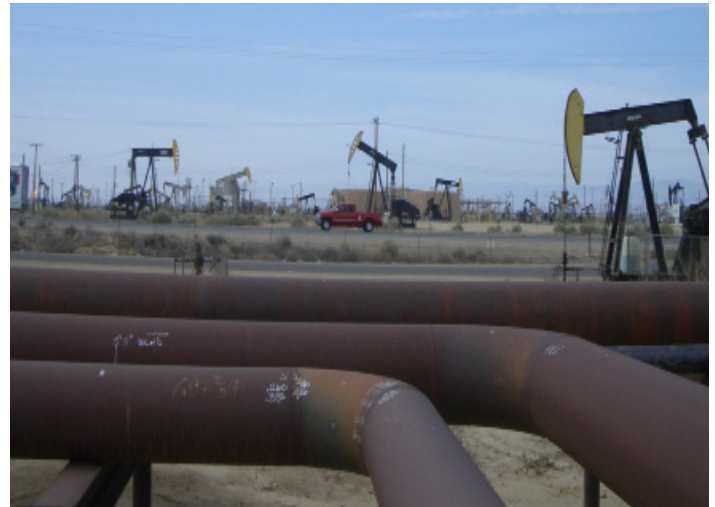
A view of the inner radius of the 1D elbow.

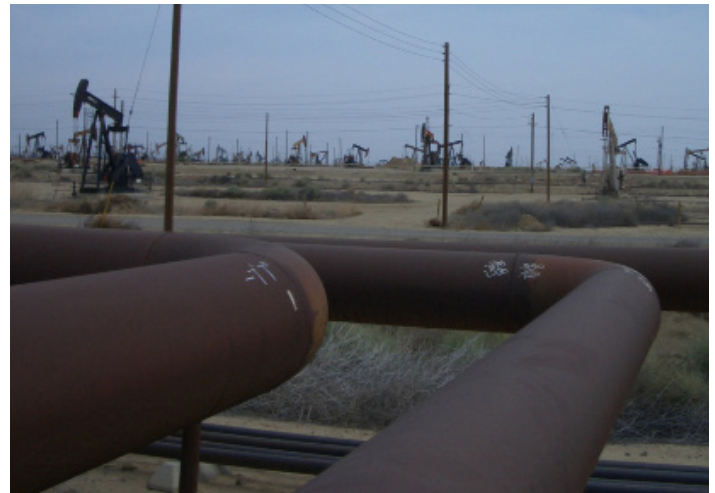
- Defect located in one of the two elbows within the test range.
- The defect is circumferentially aligned with the outer radius where the erosion type defects are commonly found.
- UT confirms the elbow defect has a 65% wall loss.

A view of the outer radius of the 1D elbow.
