Case Study 11: Wall Penetrations

Job Details

- 16" Crude Oil line
- Spiral wrap insulation
- Concrete anchor supports

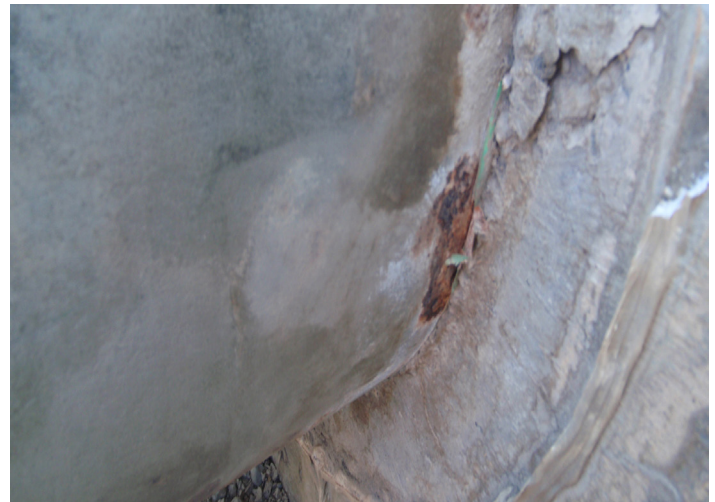
- HD ring increases the sensitivity in defect detection
- HD ring reduces the influence of the interface
- Severe defect was identified at the interface location, 1.5m from the ring

A corrosion patch found at the interface location.
