Case Study 4: Earth Wall Testing

Earth walls are a common feature in petrochemical plants and tank farms where corrosion is often located at the soil/air interface.

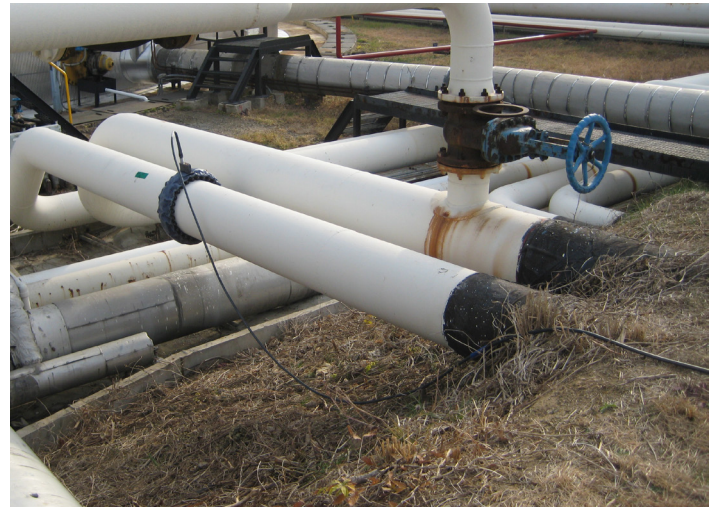
An overview of the pipe at the earth penetration

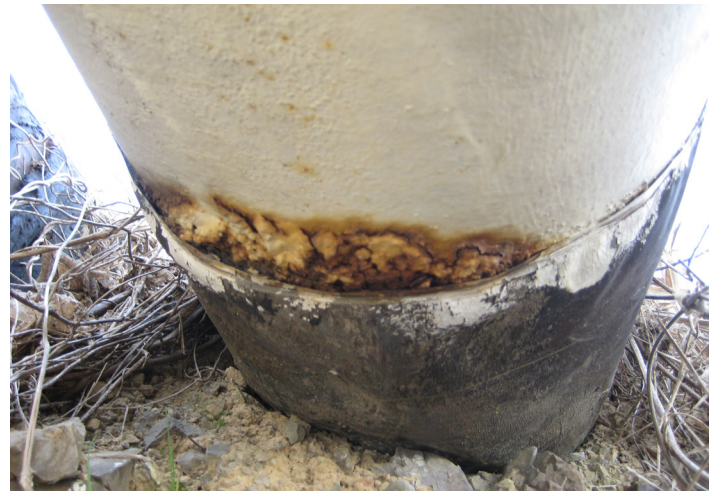
- Soil/air interface and buried section inspected
- Medium (Category 2) corrosion identified at the entrance location
- Defect axial position and circumferential orientation highlighted for follow up and repair

Corrosion patch detected at the entrance location.
