# Case Study 7: Corrosion Under Pipe Supports (CUPS)

Corrosion under pipe supports (CUPS) is a common problem encountered in pipelines, especially those subject to highly corrosive marine environments.

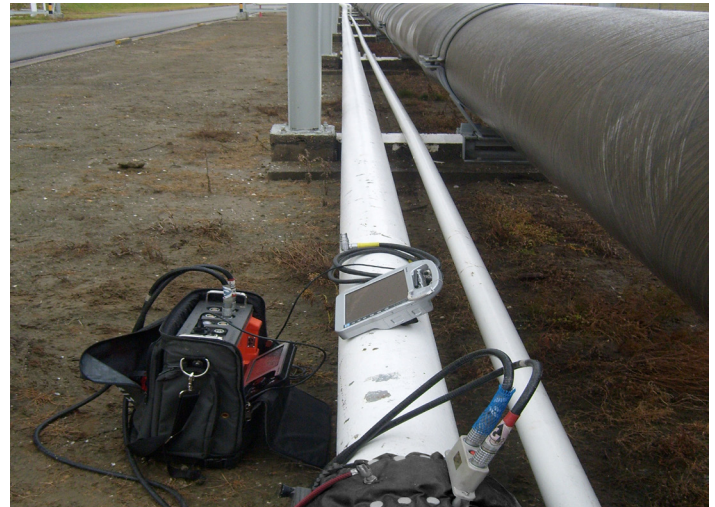
An overview of the 8" pipe under inspection.

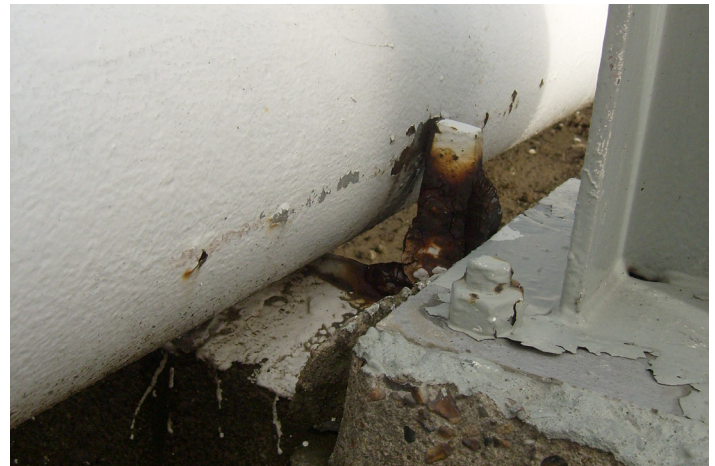
- Four support locations were screened within the test range
- Three of the support locations were found to be corroded and their severity categorised

A close up view of a corrosion under a simple support located by interpreting the guided wave test results.
