Case Study 8: Corrosion Under Insulation (CUI)

Job Details

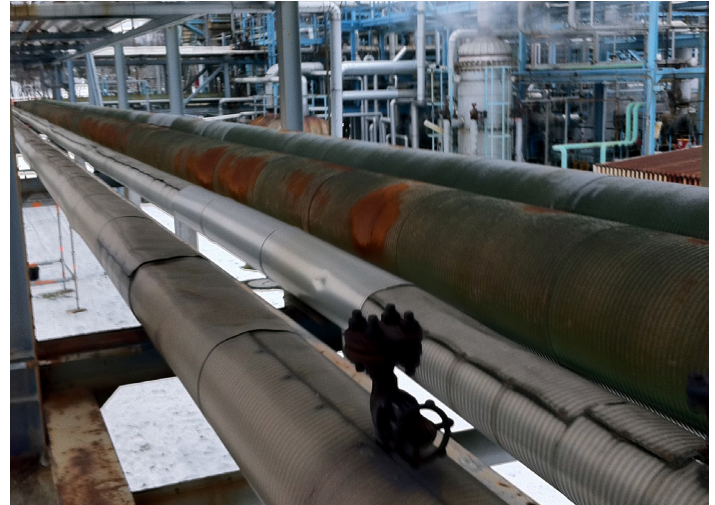
An overview of the 8" insulated pipe resting on the pipe rack.

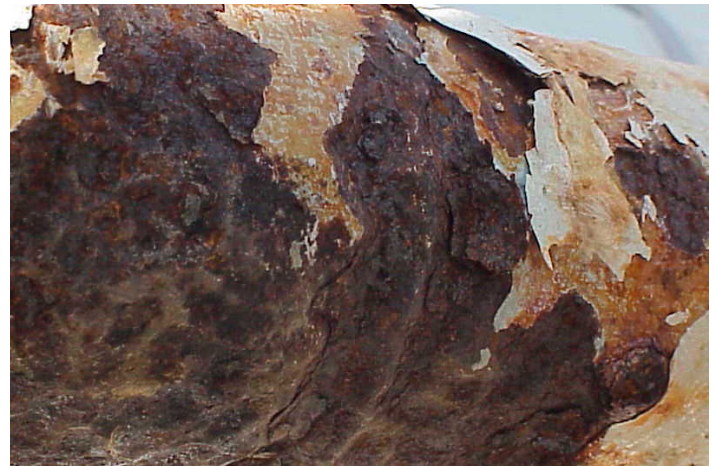
- An area of corrosion was positively identified under insulation
- Removal of insulation confirmed the presence of heavy corrosion allowing direct examination

An area of severe corrosion on the 8" insulated pipe.
